# ERRATA NOTES

## CC2500

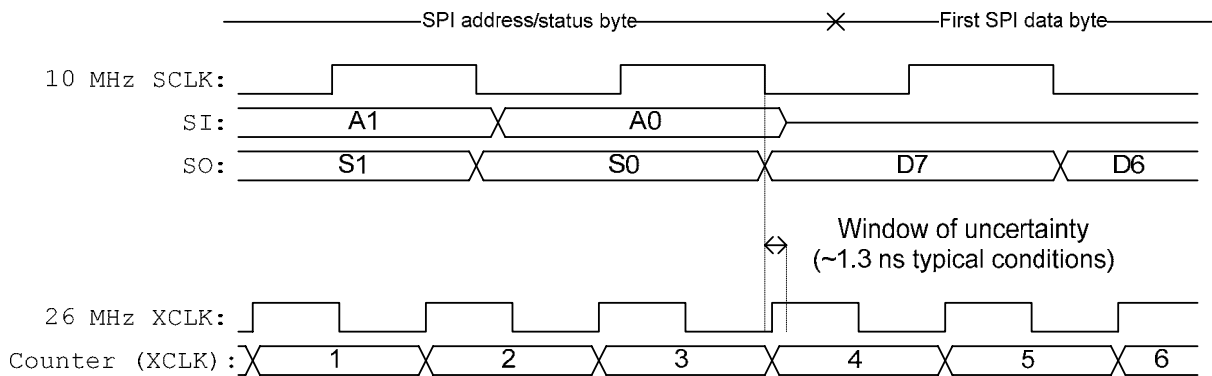
**Figure 1 Window of uncertainty (drawing not to scale)**

The erroneous value read is highlighted in red. The register read is changing from the value 64 (01000000b) to the value 63 (00111111b) on the XCLK clock at the same time that its value is latched into the SPI output shift register on the SCLK clock. If the two clock edges occur sufficiently close in time, the improper synchronization mechanism will latch some bit values from the previous register value and some bits from the next register value, resulting in the erroneous value 89 (01011001b).

Due to this synchronization issue, if the register being read changes value (synchronously with XCLK) during a certain period of time after this falling edge of SCLK then some of the bits in the read value will come from the **previous** value and some from the **next** value. This so-called window of uncertainty is about 1.3 ns for typical conditions and increases to about 2.0 ns for worst-case conditions (1.8 V VDD, 85 °C).

Figure 1 shows a timing diagram of an SPI read that fails when reading a fictitious counter being updated internally each **XCLK**. Since the counter update from value **3** (011b) to **4** (100b) within the window of uncertainty, the read value could be any one of 0-7 (000b, 001b, 010b, 011b, 100b, 101b, 110b, 111b) depending on exactly when the positive edge of **XCLK** falls within the window of uncertainty.

If it is important to **ensure** that read values are not corrupted, reading of one of the affected registers should be done repeatedly until the same value is read twice in succession. If the rate at which the register is read is guaranteed to be at least twice as fast as the expected register update rate, then an upper bound on the number of required reads is four and the average number of reads slightly more than two.
